Airsafe Surveys Ltd

Demolition / Refurbishment Asbestos Survey Report

Williams Press

20th April 2015

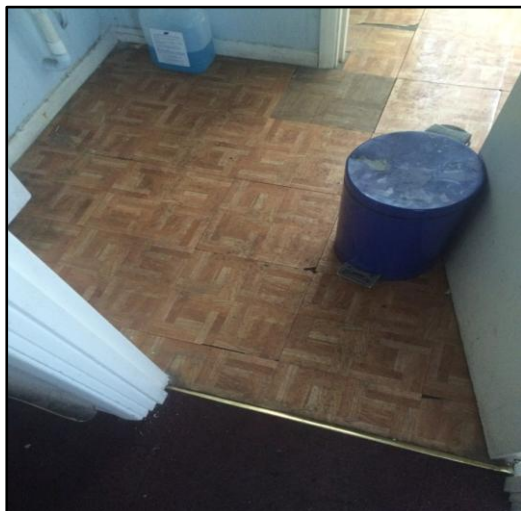
Sample Ref: B01 Location: Paper Store W/C Floor

Material Sampled: Vinyl Flooring

Analysis Result: **No Asbestos Detected**
Approximate Quantity:
Product Type:
Condition:
Surface Treatment:

Material Assessment Score: **0**

Remarks / Recommendations: N/A

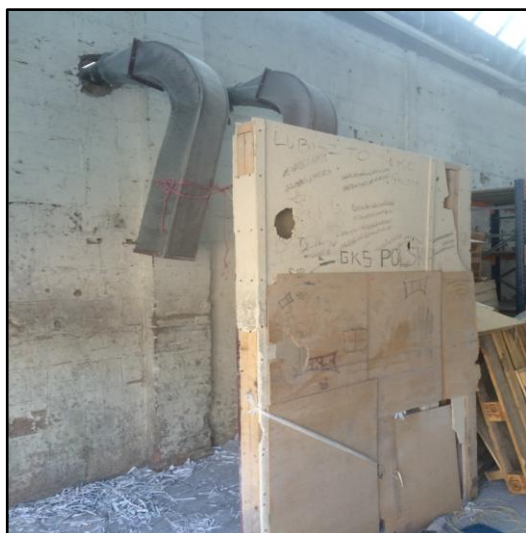
Sample Ref: B02 Location: Bailing Boxing to Small Room

Material Sampled: Supalux (New Fibre Insulation Board)

Analysis Result: **No Asbestos Detected**
Approximate Quantity:
Product Type:
Condition:
Surface Treatment:

Material Assessment Score: **0**

Remarks / Recommendations: N/A

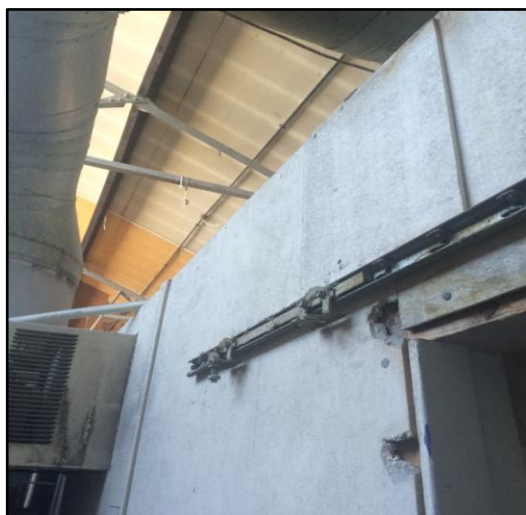
Sample Ref: B03 Location: Bindery Workshop Machine Room

Material Sampled: Supalux (New Fibre Insulation Board)

Analysis Result: **No Asbestos Detected**
Approximate Quantity:
Product Type:
Condition:
Surface Treatment:

Material Assessment Score: **0**

Remarks / Recommendations: N/A

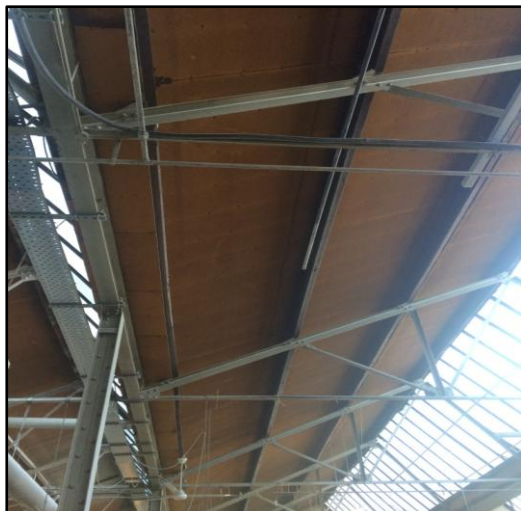
Sample Ref:	B04	Location:	Bindery Panels to Ceilings and Walls
-------------	-----	-----------	--------------------------------------

Material Sampled: Fibre Board

Analysis Result: **No Asbestos Detected**
 Approximate Quantity:
 Product Type:
 Condition:
 Surface Treatment:

Material Assessment Score: **0**

Remarks / Recommendations: N/A

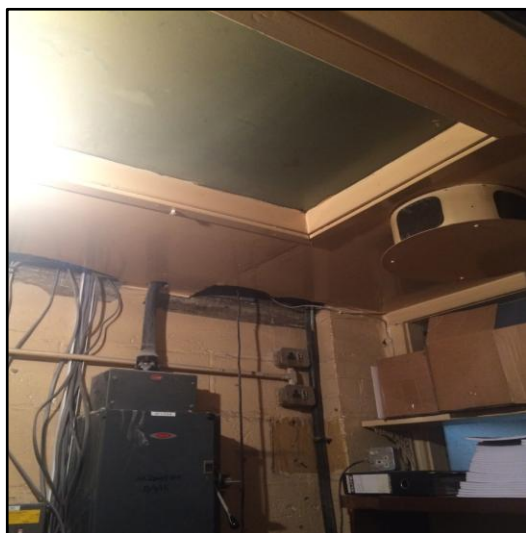
Sample Ref:	B05	Location:	Office Electrical Cupboard Wall Panels
-------------	-----	-----------	--

Material Sampled: Cement

Analysis Result: **Chrysotile (white) Asbestos**
 Approximate Quantity: 20 m²
 Product Type: **Asbestos Re-inforced Composites**
 Condition: **Low Damage**
 Surface Treatment:

Material Assessment Score: **3**

Remarks / Recommendations: Manage In Situ
 Normal recommendation would be to remove
 But as this area is staying in Situ manage.
 If refurbishment is likely to disturb then Removal

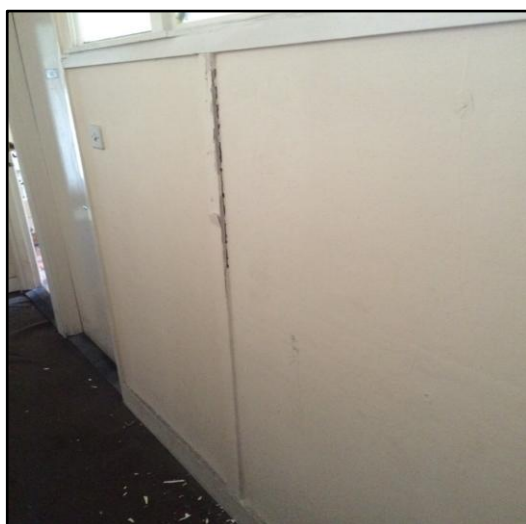
Sample Ref:	B06	Location:	Office Wall Panels
-------------	-----	-----------	--------------------

Material Sampled: Insulation Board

Analysis Result: **Amosite (brown) Asbestos**
 Approximate Quantity: 16 m²
 Product Type: **AIB / Millboards / Textiles**
 Condition: **Good Condition**
 Surface Treatment: **Cement / Sealed AIB / Enclosed Lagging**

Material Assessment Score: **5**

Remarks / Recommendations: Manage In Situ
 Normal recommendation would be to remove
 But as this area is staying in Situ manage.
 If refurbishment is likely to disturb then Removal
 By a licensed contractor.

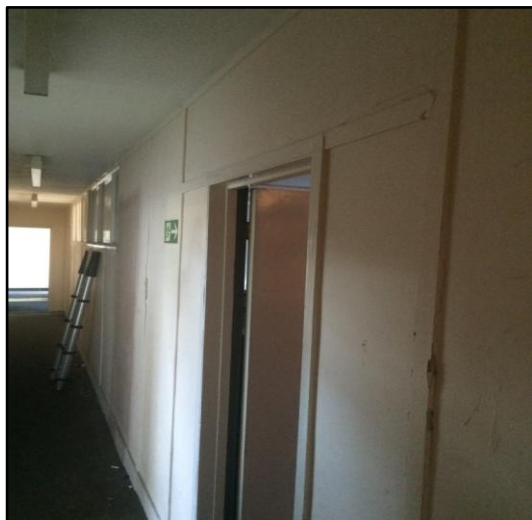
Sample Ref:	B07	Location:	Office Wall Panels
-------------	-----	-----------	--------------------

Material Sampled: Cement

Analysis Result: **Chrysotile (white) Asbestos**

Approximate Quantity: 36 m²

Product Type: **Asbestos Re-inforced Composites**

Condition: **Good Condition**

Surface Treatment: **Cement / Sealed AIB / Enclosed Lagging**

Material Assessment Score: **3**

Remarks / Recommendations: Manage In Situ

Normal recommendation would be to remove

But as this area is staying in Situ manage.

If refurbishment is likely to disturb then Removal

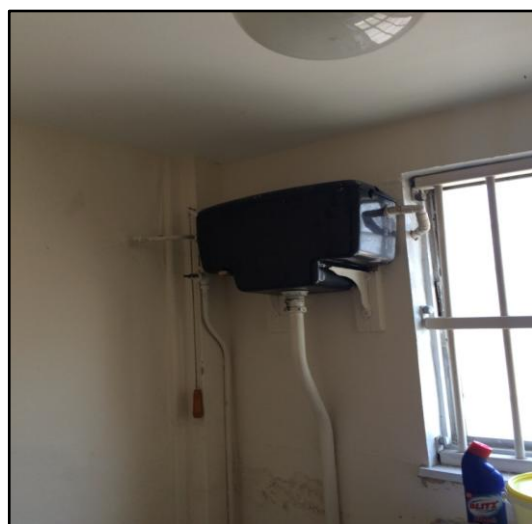
Sample Ref:	B08	Location:	Gents W/C
-------------	-----	-----------	-----------

Material Sampled: Composite Toilet Cistern

Analysis Result: **Amosite (brown) Asbestos**

Approximate Quantity: 1 m²

Product Type: **Asbestos Re-inforced Composites**

Condition: **Good Condition**

Surface Treatment: **Composite Materials**

Material Assessment Score: **3**

Remarks / Recommendations: Manage In Situ

Normal recommendation would be to remove

But as this area is staying in Situ manage.

If refurbishment is likely to disturb then Removal

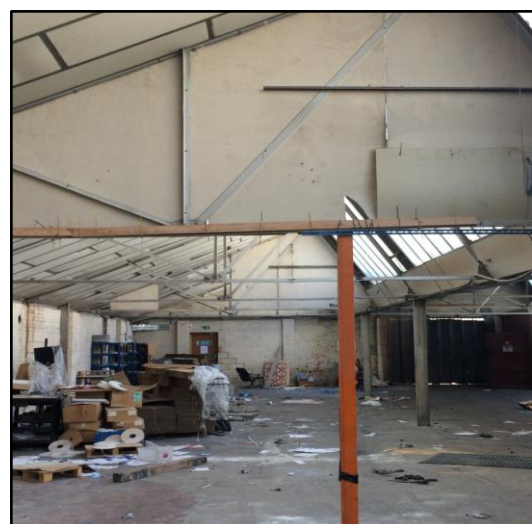
Sample Ref:	B09	Location:	10 Col Room & Storage Panels
-------------	-----	-----------	------------------------------

Material Sampled: Supalux (New Fibre Insulation Board)

Analysis Result: **No Asbestos Detected**

Material Assessment Score: **0**

Remarks / Recommendations: N/A

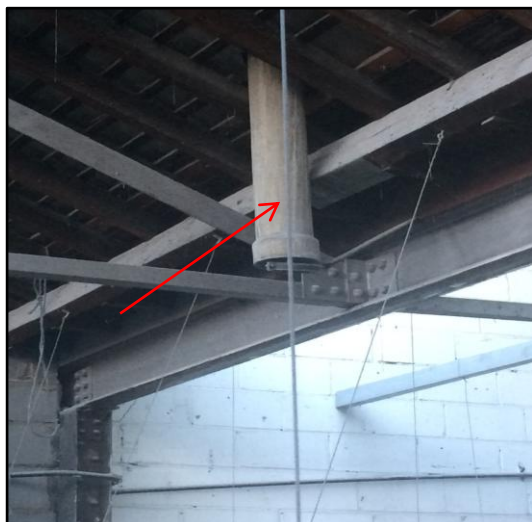
Sample Ref:	V01	Location:	Above Studio
-------------	-----	-----------	--------------

Material Sampled: Pre-formed cement Flue pipe

Analysis Result: **Chrysotile (white) Asbestos**

Approximate Quantity: 1 lm

Product Type: **Asbestos Re-inforced Composites**

Condition: **Good Condition**

Surface Treatment: **Cement / Sealed AIB / Enclosed Lagging**

Material Assessment Score: **3**

Remarks / Recommendations: Manage In Situ Unable to access due to height and Location
Normal recommendation would be to remove
But as this area is staying in Situ manage.
If refurbishment is likely to disturb then Removal

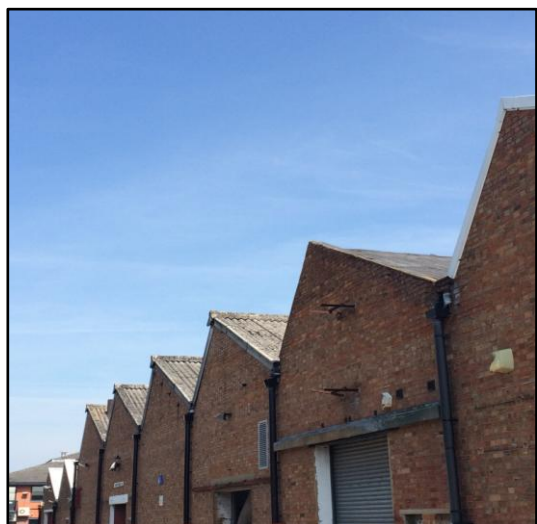
Sample Ref:	V02	Location:	External Roof Area
-------------	-----	-----------	--------------------

Material Sampled: Corrugated Cement Sheets

Analysis Result: **Chrysotile (white) Asbestos**

Approximate Quantity: 2,250 m²

Product Type: **Asbestos Re-inforced Composites**

Condition: **Good Condition**

Material Assessment Score: **2**

Remarks / Recommendations: Manage In Situ Unable to access due to height and Location
Normal recommendation would be to remove
But as this area is staying in Situ manage.
If refurbishment is likely to disturb then Removal

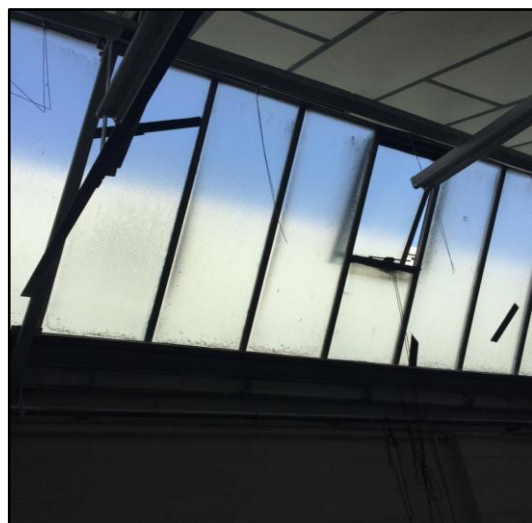
Sample Ref:	V03	Location:	Sky Lights
-------------	-----	-----------	------------

Material Sampled: Rope Gaskets

Analysis Result: **Chrysotile (white) Asbestos**

Approximate Quantity: Throughout

Product Type: **AIB / Millboards / Textiles**

Condition: **Good Condition**

Surface Treatment: **Composite Materials**

Material Assessment Score: **3**

Remarks / Recommendations: Manage In Situ Unable to access due to height and Location
Normal recommendation would be to remove
But as this area is staying in Situ manage.
If refurbishment is likely to disturb then Removal
Presumed window to contain
