Schedule of Condition

Units 9-11 & 21-27
Clivemont Road
Maidenhead
Berkshire
SL6 7BU

Jaswar Maghi and Inderjit Malhi
T/A Trends Interiors
21 Clivemont Road
Maidenhead
Berkshire
SL6 7BU

03rd August 2015

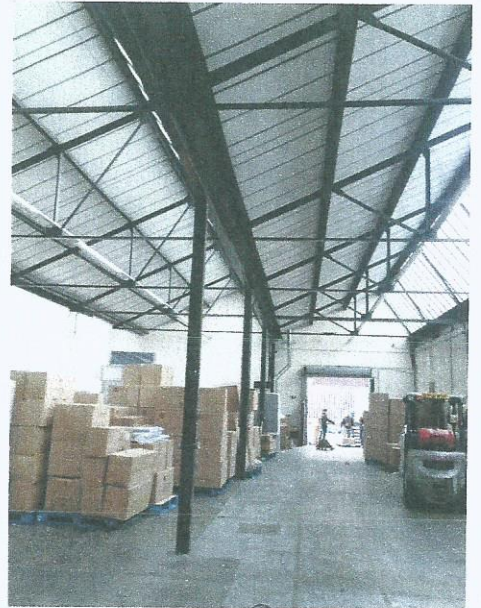
③

2.19		Vertical crack in brickwork.	5, 6
2.20		Paintwork peeling off brickwork.	7
		Pair of timber entrance doors with splintered panels.	8, 9
2.21	Roof	Steel framed northern light designed roof incorporating, glass lights, corrugated asbestos sheeting lined with insulation boarding.	3

2.22		Insulation panels generally fair 4 no panels broken.	3
2.23		Glass lights dirty and stained.	20
3.0	Units 10 & 11		
3.1	Floor	Office Area Solid concrete floor slab with remains of rubberised flooring, exposed concrete with open expansion joints and cracks – Poor Quality.	17,18,19 27, 28

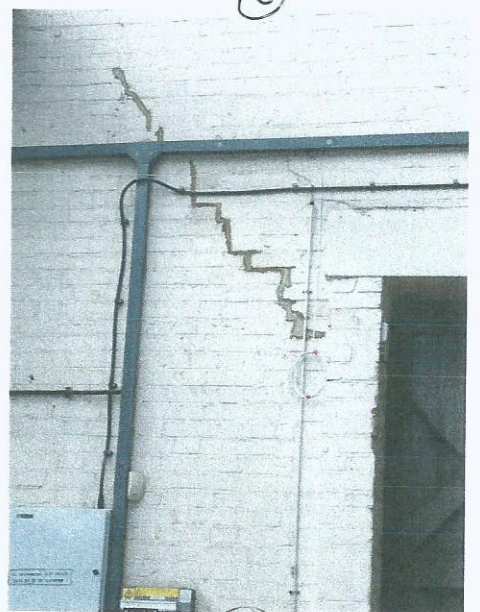
⑥

No	Description	Comments & Condition	Photos
	UNIT 9		
2.1	Floor	Solid concrete laid in bays with expansion joints with a powerfloat finish.	7, 53,54 55, 56
2.2		Cracks in surface.	7, 54
2.3		Broken edges at expansion joints.	27, 28
2.4		Scuffed surfaces.	28
2.5		Damp penetration on surface.	29
2.6	Walls Left Hand Flank	Concrete blockwork finished fair faced with painted finish.	21-26
2.7		Wall pitted and marked.	21, 22
2.8		Crack due to impact damage.	5, 6
2.9		Roller shutter side entrance.

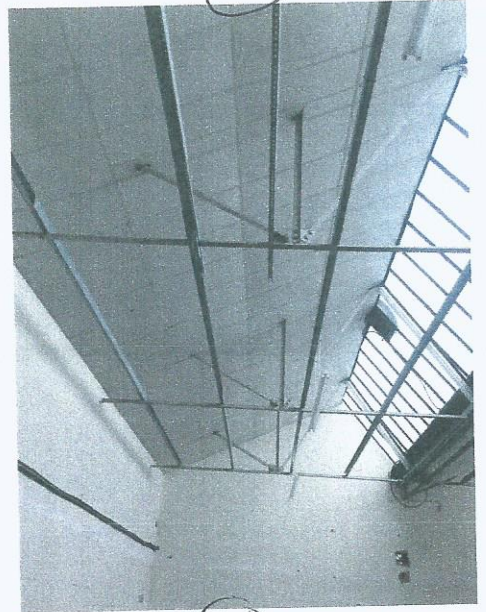
(14)

Units 10 & 11 (cont)	Warehouse Section (cont)	
3.23	Front	Solid brickwork finished fair faced with painted finish - Poor	14,16
3.24		Water stains due to leakage.	32

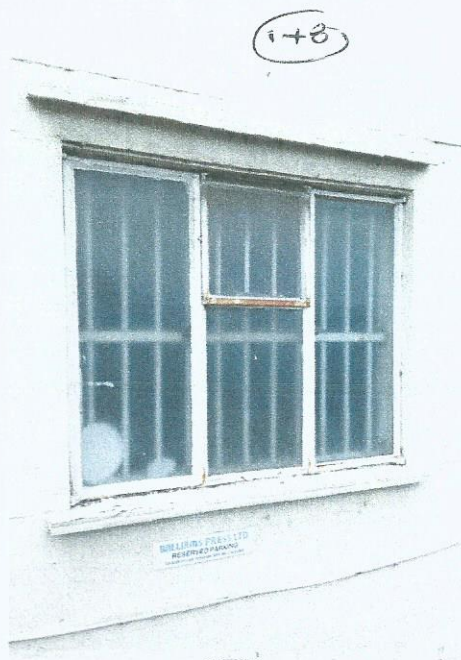
6.16		Metal door frame corroded.	140
6.17		Front timber double doors poor painted finish with exposed timbers.	140
6.18		Metal casement window corroded.	148

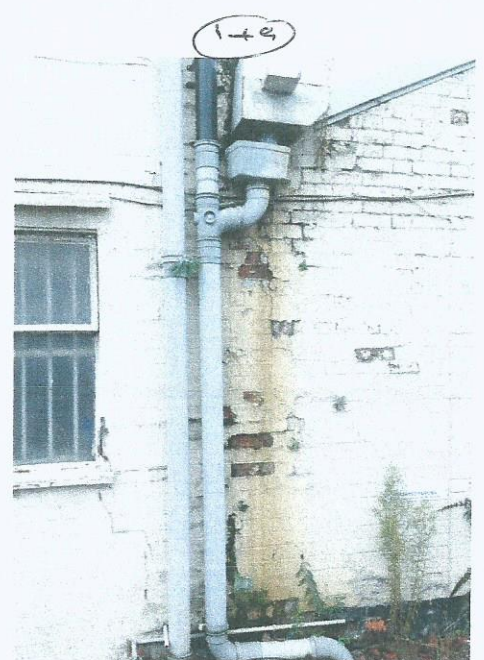
6.19		Staggered cracking in brickwork from hopper head to metal window.	143 149
6.20		Damp patch behind rainwater downpipe.	149
	Units 26/27		
6.21		Solid brickwork finished fair faced with a painted finish - Poor	150,152

6.22		Damp staining behind rainwater hopper.	149
6.23		Vegetation growing up wall.	153,156 157
6.24		Vertical cracking below rainwater hopper.	149
7.0		REAR ELEVATIONS Solid brickwork finished fair faced.	111-119 121-126
