Schedule of Condition

Units 9-11 & 21-27
Clivemont Road
Maidenhead
Berkshire
SL6 7BU

Jaswar Maghi and Inderjit Malhi
T/A Trends Interiors
21 Clivemont Road
Maidenhead
Berkshire
SL6 7BU

03rd August 2015

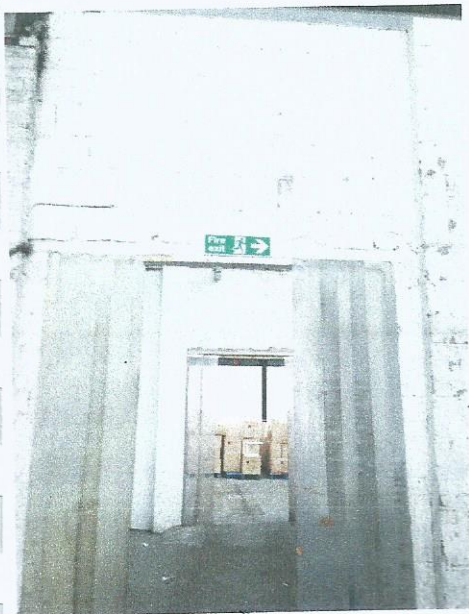
10

5.15		Pitted surface with holes.	85
5.16		Horizontal cracking around door opening.	10,11
5.17		Damp evident in bottom five courses of brickwork.	89,90
5.18		Sliding shutter doors - Dirty	91

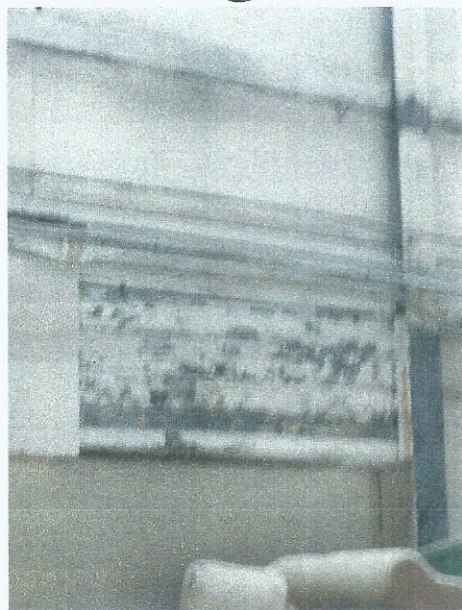
66

5.21		Damp stains due to gutter leakage.	66,67,68 69
5.22		Pitted surface with holes.	83
5.23	Front Wall	Solid brickwork finished fair faced with painted finish.	61,62

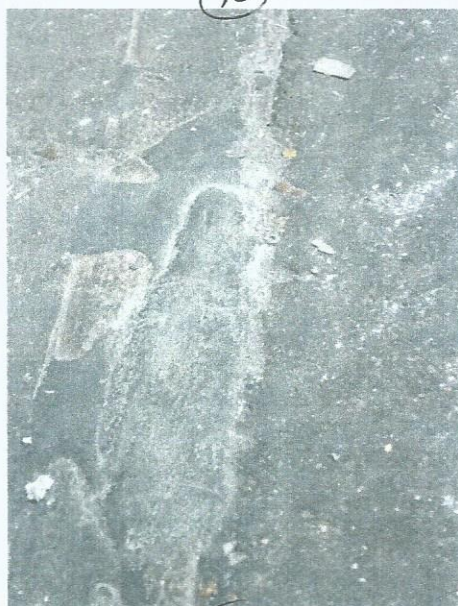
5.24		Paintwork peeling off surface.	63,65
5.25		Plaster finish lower ground – pitted and cracked.	
5.26		Water staining due to leakages.	61,62,63
5.27	Floor	Solid concrete floor slab laid in bays with expansion joints - Poor	70,94

Units 26/27 (cont)	Warehouse Area (cont)	
5.30	Floor (cont)	Water staining around column bases.	59
5.31		Surface scuffed and marked.	70
5.32		Areas of concrete made good.	94

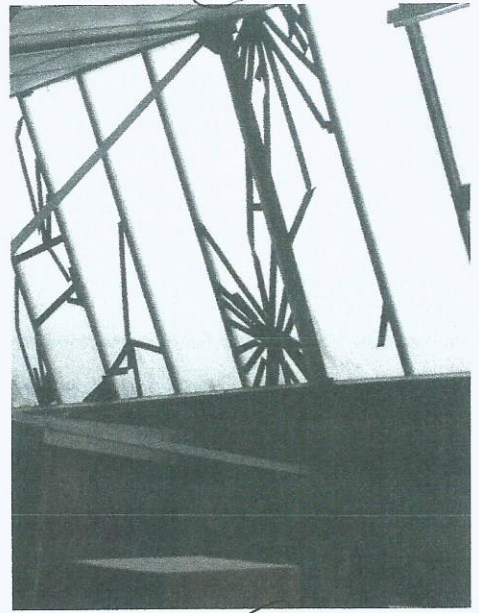
86

5.34		Insulated panelling – missing exposing underside of profiled metal roof.	77,78,80
5.35		7 no Glass panels cracked and broken.	79,86
5.36		Damp patches on floor	75

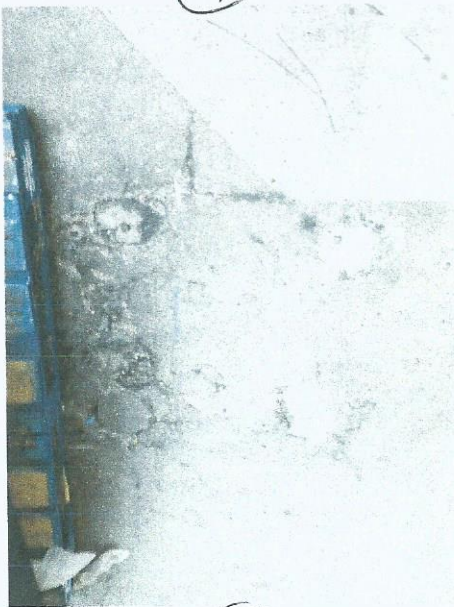
4.23		Damp staining due to guttering	
4.24		Underside of roof support timber	94
4.25		Glass sheeting – Dirty and stained	87

Units 26/27 (cont)	Warehouse Area (cont)	
5.9	Left Hand Flank Walls (cont)	Holes in surface of bricks.	90
5.10		Worn and pitted surface.	90
5.11		Old fixing holes.	87

5.28		Cracking in surface.	94
5.29		Sheared bolt holes not made good.	87

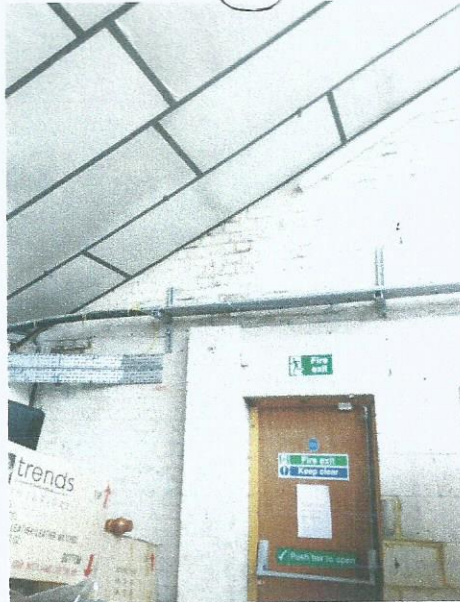
88

5.12		Water staining from gutter leakages.	92
5.13	End Wall	Solid brickwork finished fair faced with a painted finish - Poor	88,89
5.14		Paintwork peeling off surface of brickwork.	89

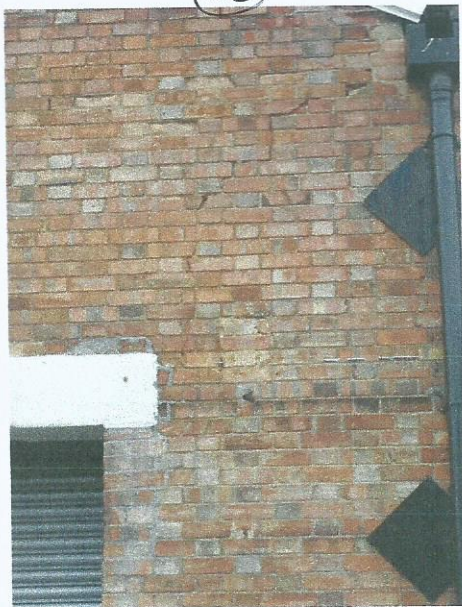
96

7.1		Vertical cracking over roller shutter doors.	96,97

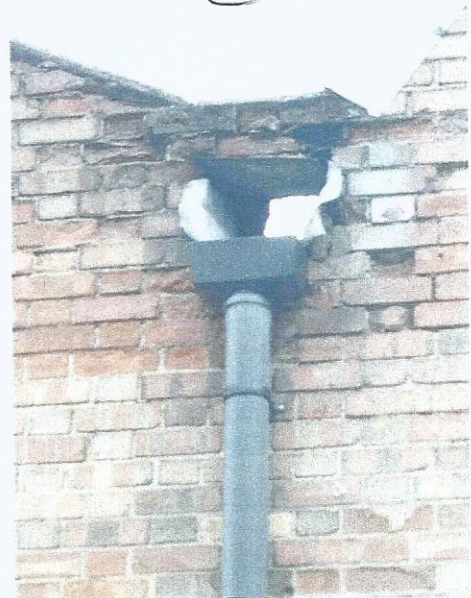
7.2		Rear Elevations (cont)	
		Cracking between lintel and rainwater hopper.	98
7.3		Damaged reveals around door openings.	99
8.0	Services Not Tested	SERVICES Electrical and Gas Installations Heating Systems Surface Water Drainage Foul Water Drainage	
9.0		EXTERNAL ROOFS Roofs external condition do not form part of this Schedule of Condition

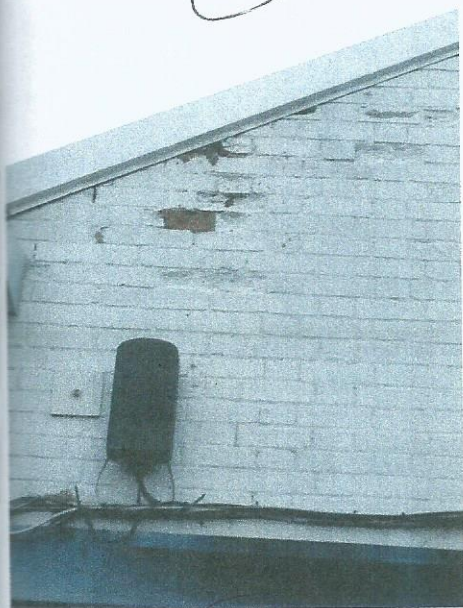
6.0	Unit 9	FRONT EXTERNAL ELEVATIONS	
6.1		Solid brickwork finished fair faced with a painted finish.	127,128 129
6.2		Paintwork flaking.	129
6.3		Vertical crack in brickwork above beam over timber entrance doors.	131

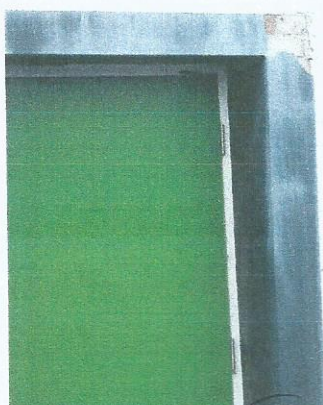
6.7		Rendering in door surround broken away.	133
6.8		Brickwork around hopper head eroded due to damp penetration.	134
6.9		Horizontal cracking under door beam.	136

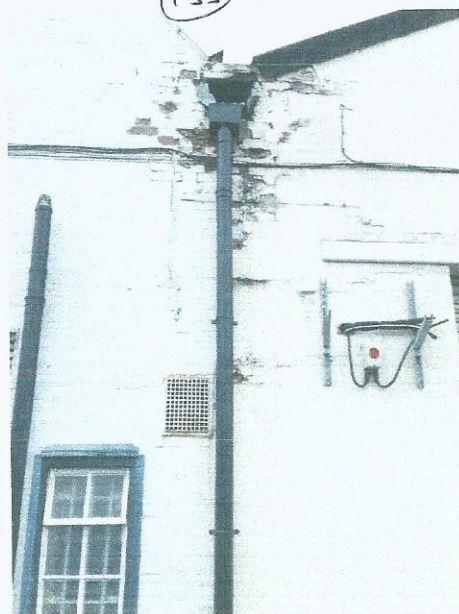
135

6.13		Damp staining next to entrance doors.	139
6.14		Vertical cracking in brickwork below gutter down to window.	135,136 143
6.15		Vertical cracking in brickwork under window to ground level.	142

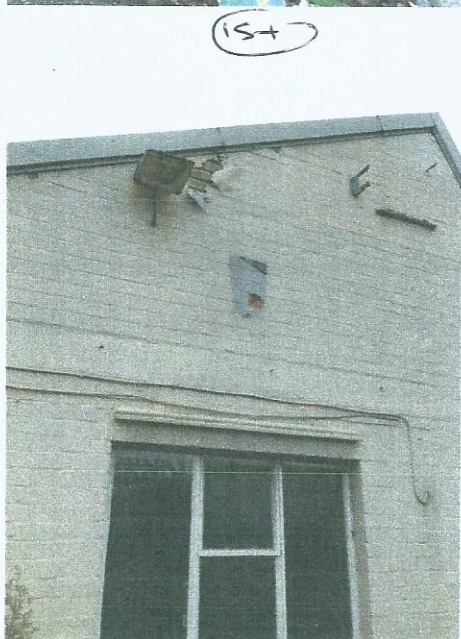
153

6.22		Damp staining behind rainwater hopper.	149
6.23		Vegetation growing up wall.	153,156 157
6.24		Vertical cracking below rainwater hopper.	149
7.0		REAR ELEVATIONS Solid brickwork finished fair faced.	111-119 121-126
